AEROPRAKT

SERVICE BULLITEN

No. SB A-32-04

Model: A-32

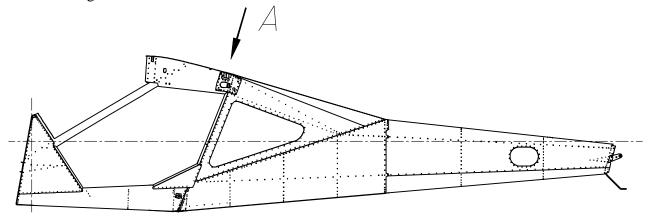
Fig.1

The rivets attaching the roof panel to the frame No.3 may become loose due to fatigue.

- ▲ WARNING: Non-accomplishing this work may result in failure of fuselage.
- **3.1**) Inspect the rivet joint of the roof panel and frame No.3 (Fig.1, 2, 3), check number of the rivets (intervals between them) and their condition.
- **3.2**) If number of the rivets (intervals between them) are as shown in Fig.3 and the rivets are not loosened, this repair work is not needed.
- **3.3**) If number of the rivets (intervals between them) are as shown in Fig.2 and the rivets are loosened, this repair work must be accomplished.
- **3.3.1**) Mark and drill with &3.1 mm drill bit the holes for additional rivets according to Fig.3.
- **3.3.2**) Insert and set the additional $\&3\times8$ rivets.
- **3.3.3**) Undrill the loosened rivets with &3.1 mm drill bit and install the new &3×8 rivets.
- **3.3.4**) Paint the rivet heads with color of the airplane.
